Article

uhuMEBr: Energy Refurbishment of Existing Buildings in Subtropical Climates to Become Minimum Energy Buildings

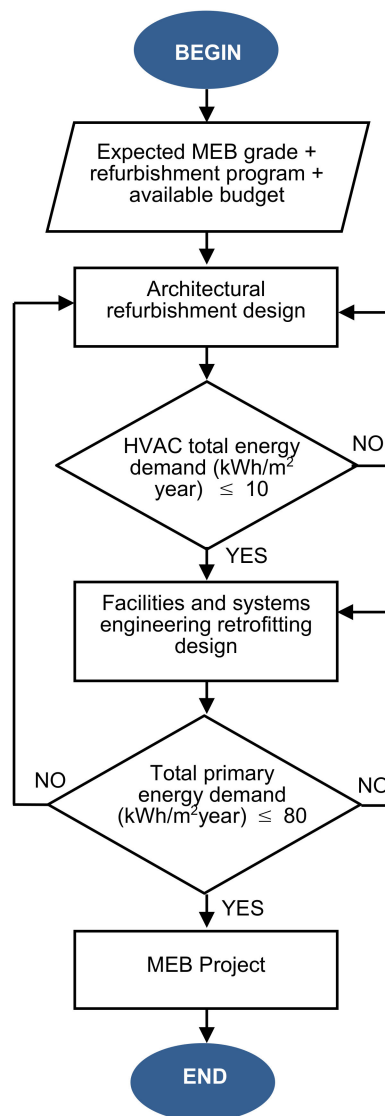
Figure 2. Energy refurbishment project algorithm.

Figure 2 shows the algorithm that implements the *energy refurbishment project* phase. It is important to keep in mind that, mentioned before, in building refurbishment the variety of cases can be significant; so, uhuMEBr cannot set all the paths to achieve MEB requirements, but only if they are reached or not. It should be noted that, even in the case of typical and apparently uniform residential buildings, it is possible that over time some dwellings may have undergone refurbishments and others may have not; a typical example is the carpentries. Therefore, when facing the complete refurbishment of a building, the actual situation of each dwelling must be taken into account. That is why the previous *measurement campaign* and *data analysis* is so important (Figure 1).

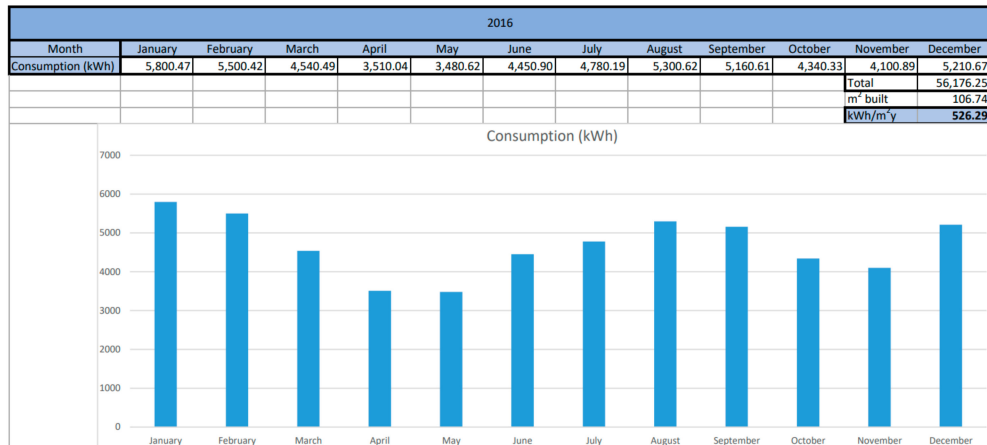
Figure 5. Monthly energy consumption in a whole year (2016) before refurbishment.

Figure 5 shows the annual dwelling primary energy demand. The obtained value was 526.29 kWh/m²year. This value is far away from the MEB of Table 1. The most demanded month was January with a total of 5800.47 kWh; the less demanded months were April and May with a total of 3510.04 and 3480.62 kWh, respectively.

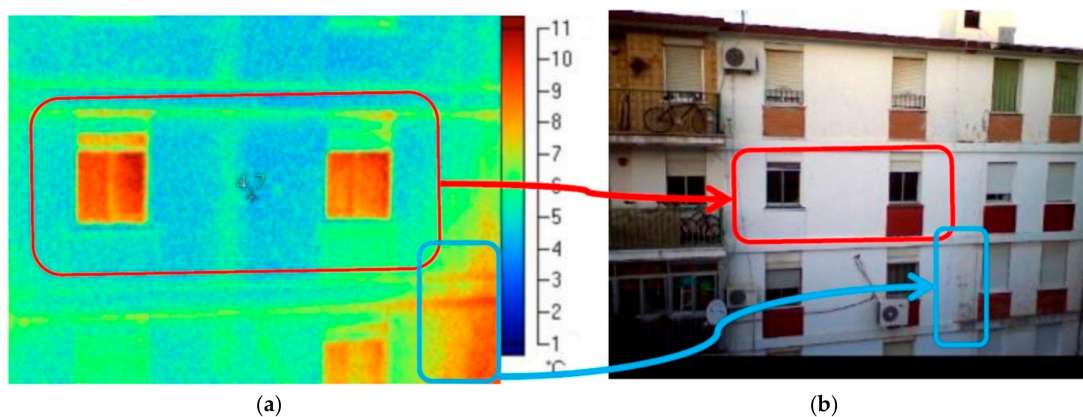
Figure 7. (a) Thermal behavior of the dwelling exterior façade; (b) Visual aspect.

Figure 7a shows the thermal behavior of the dwelling exterior façade (enclosed in red). Notice the weak points in windows and shutter boxes. Moreover, observe the behavior of a dwelling on the bottom right (enclosed in blue) in the same building. This dwelling (Figure 7b) has a very deteriorated façade (enclosed in blue), unlike the one that is enclosed in red that is freshly painted. Figure 8 shows the thermal behavior of the dwelling façade that overlooks the backyard. Notice, again, the weak points in windows and shutter boxes. Note also that the interior I (Figure 8a) is more deteriorated than the exterior (Figure 8b). Figures 7 and 8 show the poor thermal behavior of the dwelling and its need to improve it.

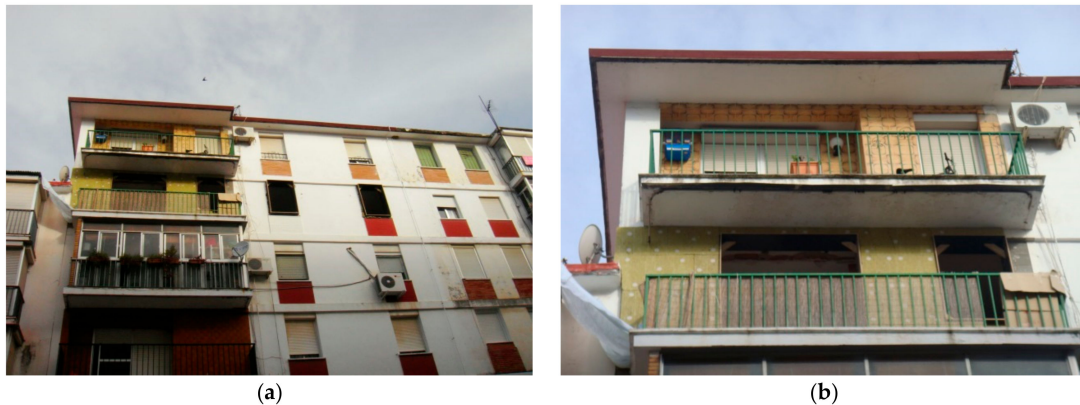
Figure 11. (a) Exterior façade of the dwelling under refurbishment; (b) Balcony façade detail.

Figure 11a,b shows the ETICS. In Figure 11a, the balcony façade, still under construction, is enclosed in blue line and the rest of the façade, already finished, is enclosed in red line. Notice the window openings still no frames or glass, and because it is mandatory, the color and relief of the façade have been preserved. Figure 11b shows the balcony façade detail with the thick rockwool that is part of the ETICS.

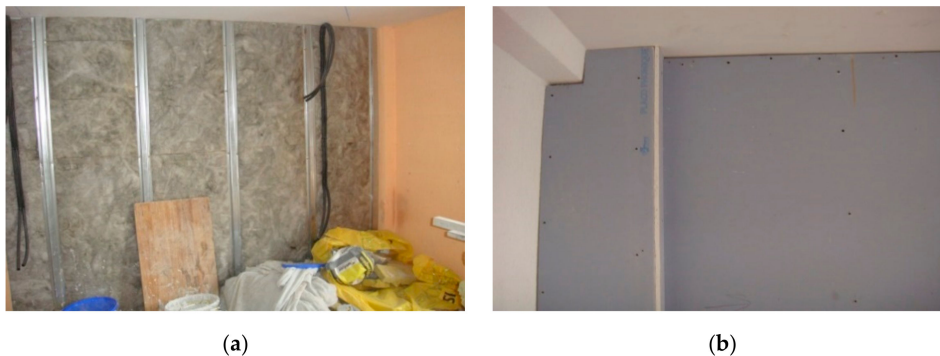
Figure 12. (a) Internal thermal insulation composite system; (b) Finished.

Figure 12 shows the internal thermal insulation composite system (applied in party walls): (a) under construction and (b) finished. Figure 13 shows an example of the new façade windows with double insulation chamber glasses and electric sliding shutter.

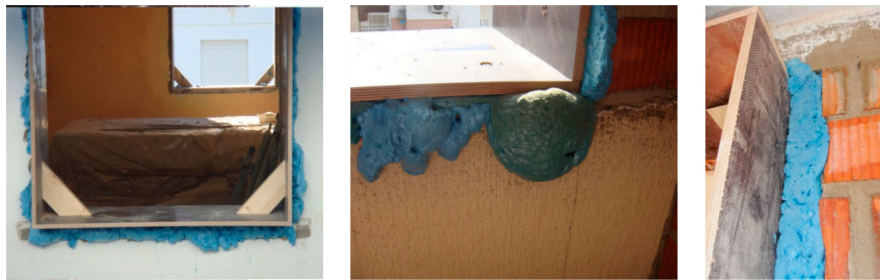
Figure 14. Special joints and high-durability flexible self-expanding polyurethane foam used.

To achieve the dwelling airtightness, a continuous layer of gypsum-cement mortar on the inner side of the thermal envelope has been applied. The facilities holes were sealed with the same mortar, applying silicone to the inside of the corrugated tubes and cable entries. Joints between carpentry and walls were filled with special joints and high-durability flexible self-expanding polyurethane foam

(Figure 14). The shutters' airtightness was improved with silicone (boxes) and brush gaskets, getting airtight the entire set.

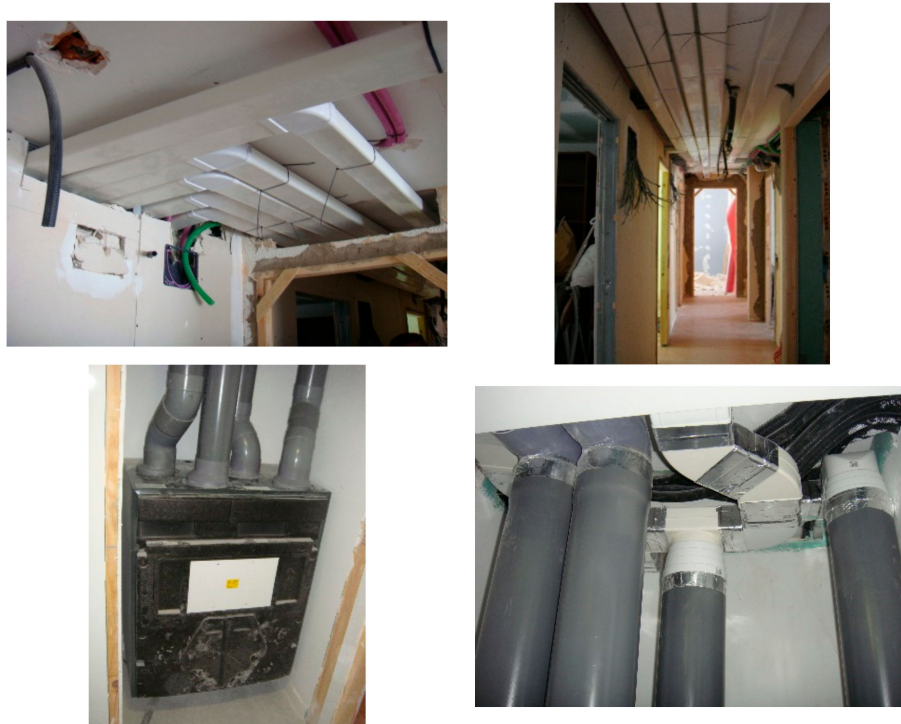
Figure 15. Double duct ventilation facility installed in the dwelling.

Regarding the double duct ventilation facility, almost all its air pipes go through the corridor ceiling (Figure 15), which was raised down 20 cm to 2.15 high—just over the door flashings—to hide them. It was a big concern can do it in a social house without affecting its habitability. With respect to ACHP, the solution to be installed was simple: an exterior unit with four wall splits, one for each room, so nothing special is worth commenting on it after what was said.

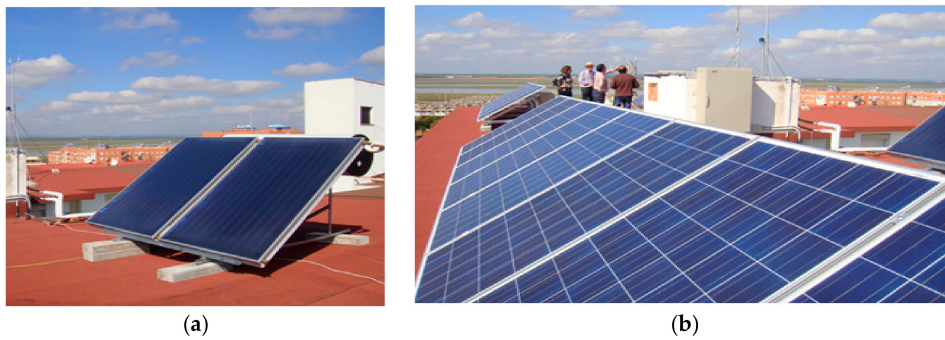
Figure 16. (a) Flat solar thermal collectors; (b) Photovoltaic panel facility.

Taking advantage of the building roof availability, all the RES facilities were mounted there. Figure 16 depicts the installed RES facilities.
