Determination of the extreme reduction of concrete strength due to Acid Mine Drainage by laboratory tests on specimens located in a real environment.

Abstract

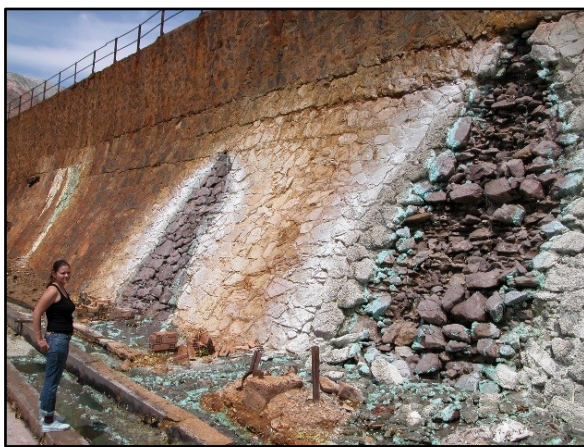
1.a. Retaining dike.

Figure 1. Structures altered by AMD.

Focusing on concrete structures, among which would be affected by this problem, it can point out the building structures made with this material, pipes, tanks, containment elements in general (dikes, retaining walls and even rockfills that use concrete), gallery plugs, bridge pillars, foundation elements, hopper columns, etc. (Figure 1).

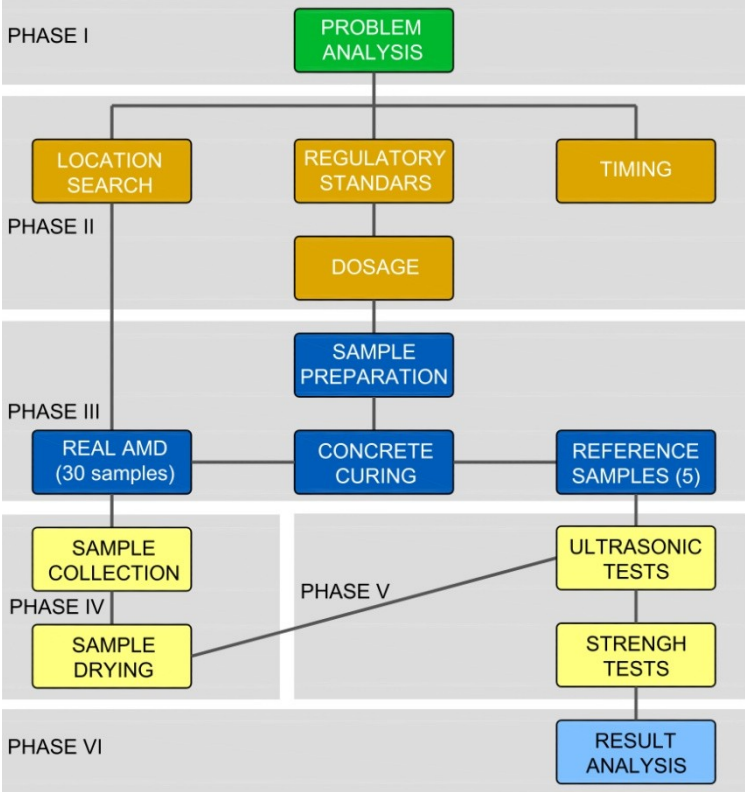
Figure 4. Work Diagram.

To better understand the procedure followed, a diagram is included with the entire process followed in the investigation (Figure 4).

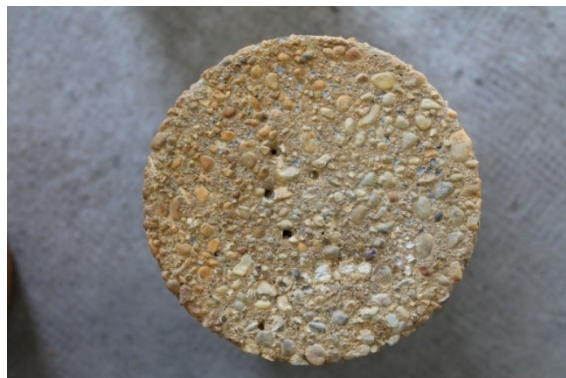
Figure 5. Example of specimens mark (after affecting by AMD).

The method of identification of the test pieces was by marking them with holes, in order to be able to identify them once they were affected by the AMD, creating their own code, beginning to read from left to right, which is known from a mark made with a chisel, this mark remaining on the left side (Figure 5).

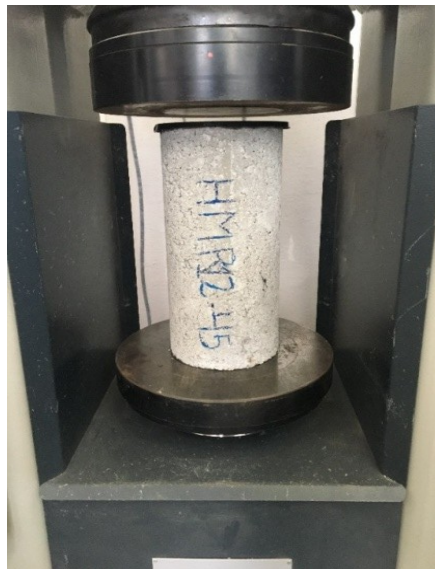
Figure 6. Specimens prepared for the compression test in the press.

In this case, the compression test was carried out on cylindrical specimens of 150x300 mm (with a curing time of 28 days) using the Automax X5 compression equipment (Figure 6). To carry out the test, the following parameters were used, according to UNE EN 12390-3 standard [41]:

- Sensibility: 20 kN
- Velocity: 0.60 MPa/s

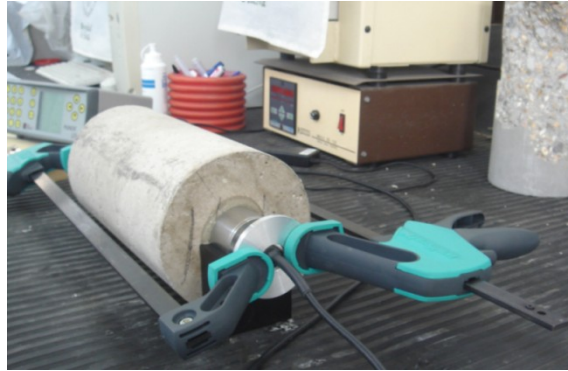
Figure 7. Ultrasonic test

The ultrasonic tests have been used as an assessment of deterioration in concrete durability. This test consists of two transducers, so that one of them emits an ultrasonic pulse; therefore, the sample is travelled by the wave from one end to the other and the velocity is measured. The equipment used was the Pundit Plus from the CNS Farnell company (Figure 7).

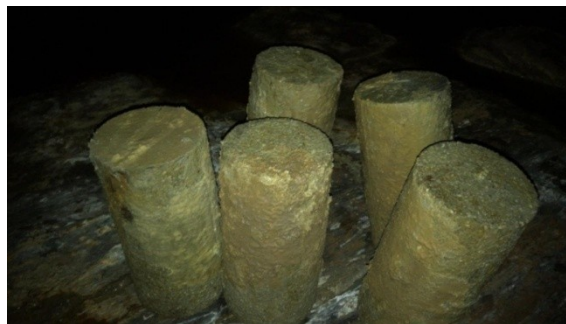
Figure 9. Specimens taken from the water with AMD.

Figure 9 shows the condition of the specimens taken out of the water after four months of exposure, appreciating outside a significant mass of gypsum paste.

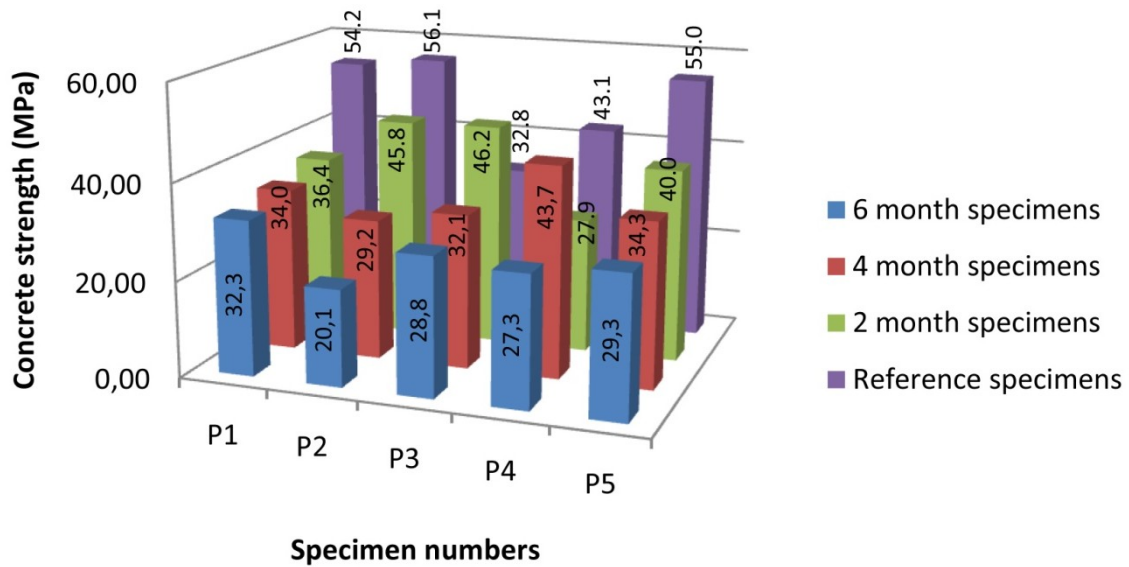
Figure 10. Compressive strength with different periods of exposure

Figure 10 graphically presents the results of the compressive strength of the specimens altered by AMD during different exposure periods. It can be already seen a clear reduction in the concrete strength over the months.
